## 7.1 A History of Doan Brook Floods

## 7.2 Where Does the Water Come From? Watershed Runoff Patterns

## 7.3 Why Is There a Flood? The Brook Under Duress

## 7.6 What Can We Do? Solutions to Flooding

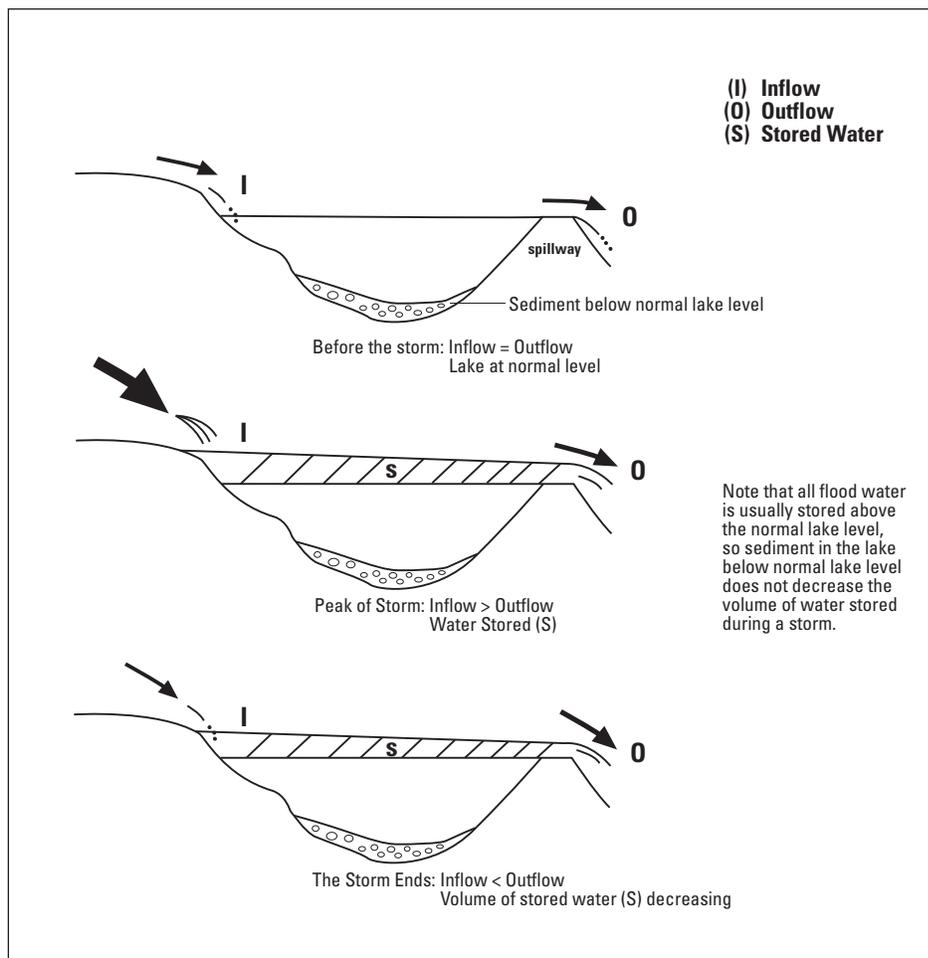
When a storm begins, water starts to flow into the lake faster than it can flow out over the spillway, and the water surface in the lake rises (see Figure 7-2). As the water surface goes up, the flow out of the lake (over the spillway) increases. The elevation of the lake at the end of the storm and the peak outflow from the lake depend upon the balance of the rate of inflow, the water surface elevation, and the outflow rate during the storm. The lakes slow and reduce downstream flood peaks by forcing water to leave the lake more slowly than it flows in and thus storing water during the storm.

**Figure 7-2** Lakes: Sediment Storage and Storm Flows

The ability of the Shaker Lakes to ease flooding in University Circle is *not* increased by *dredging the lakes*. Dredging has no impact on flood control because the volume of water stored during a storm is the volume contained in the layer of water *between the lakes' water surface at the beginning of the storm and the*

*water surface at the end of the storm.* This layer of water lies above the spillway elevation and is not filled as sediment accumulates.

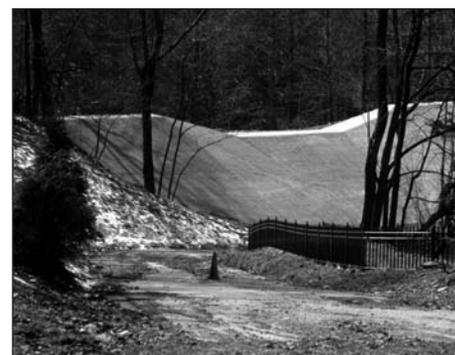
**Figure 7-3** The flood detention basin on Doan Brook just downstream from Martin Luther King, Jr., Boulevard. Photograph by L.C. Gooch.

In 1997, the City of Cleveland took advantage of some available funding and built a flood detention basin on Doan Brook just upstream from the entrance to the University Circle culvert (immediately downstream from MLK). Although the basin was intended to reduce the five- and ten-year floods in the lower watershed, subsequent studies performed during the NEORS Doan Brook Study have shown that the basin will have little or no impact on floods that occur less than about once in ten years, and will have significant impact only during very large floods (as large or larger than a flood that would occur once in fifty years). How, then, did the basin come to be built?

redesigned basin and outlet provided much less flow restriction and flood storage than the original design. In addition, analyses made as part of the NEORS Doan Brook Study suggest that inflows to the basin will be somewhat lower than those estimated by Stanley. Because of the design changes and the lower inflows, the detention basin is expected to have little or no impact on the five- to ten-year events for which it was built and to have no significant impact on flooding in University Circle except during floods that occur less frequently than once in fifty or 100 years.

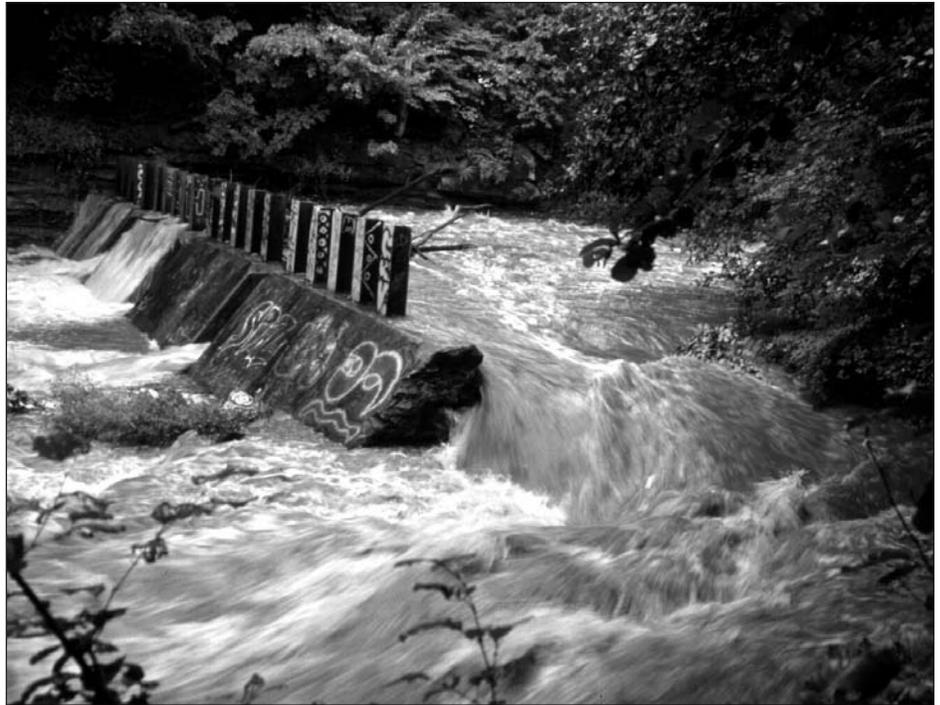
**Figure 7-4** Erosion around the end of the trash rack upstream from Martin Luther King, Jr., Boulevard is one result of high flows in Doan Brook. Photograph by L. C. Gooch
