## 5.1 How Have We Changed the Brook? Alterations to the Stream Shape

As soon as people settled near Doan Brook, they began to mold the stream to suit their use and convenience. The changes that they made fall into four main categories: construction of dams and lakes; diversion of the stream into underground culverts; construction of rigid channels to confine the brook to a set course; and other alterations to the stream channel shape.

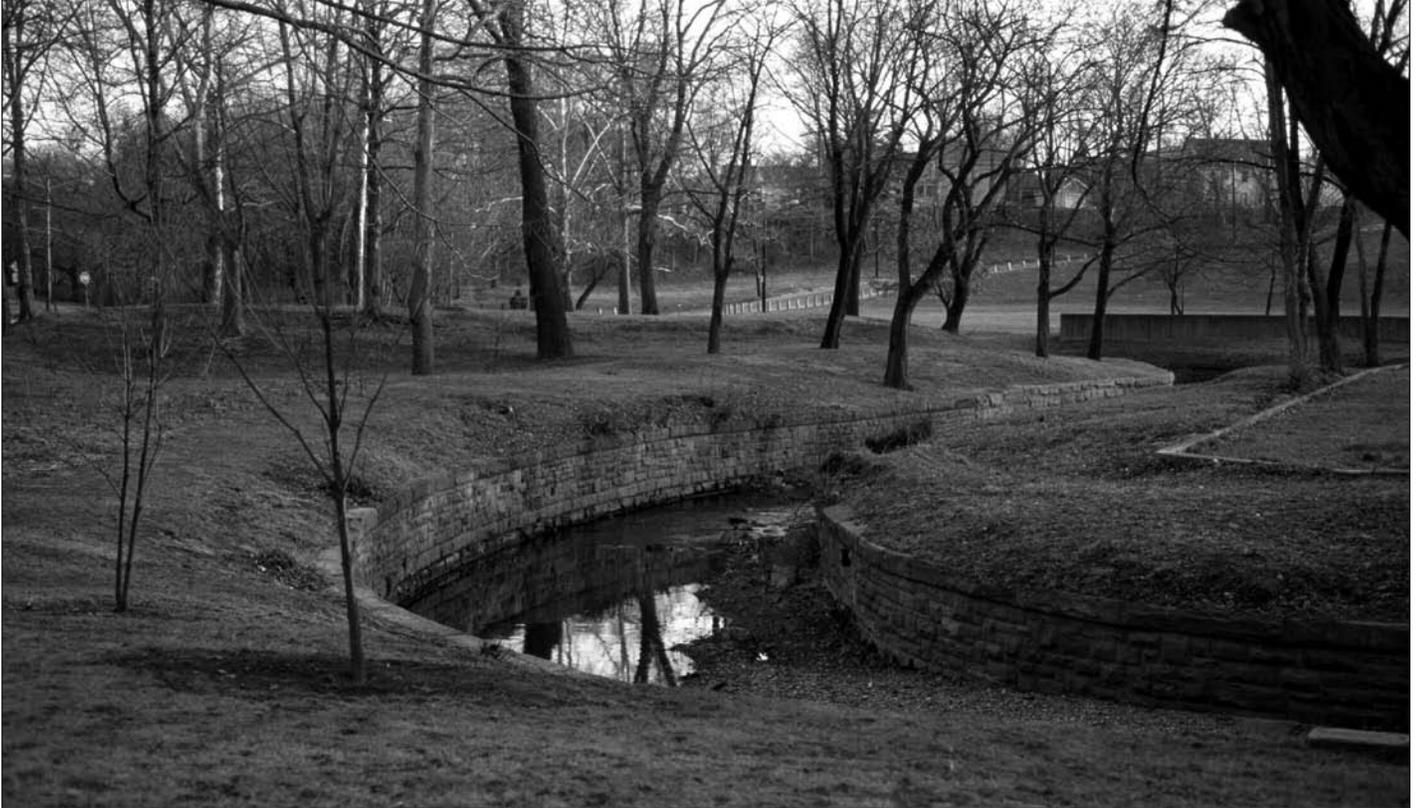
Channelized section of Doan Brook in Rockefeller Park. Photograph by L. C. Gooch.
